JONES, Gary A. - Van Niekerk, Kleyn & Edwards, Consulting Engineers,
South Africa.

SMITH, Andrew C.S. - Reef Lefebvre (Pty) Ltd., South Africa.

DESIGN, CONSTRUCTION AND MONITORING OF A REINFORCED EARTH WALL FOR RECONSTRUCTION
OF A HIGHWAY SLOPE FAILURE.

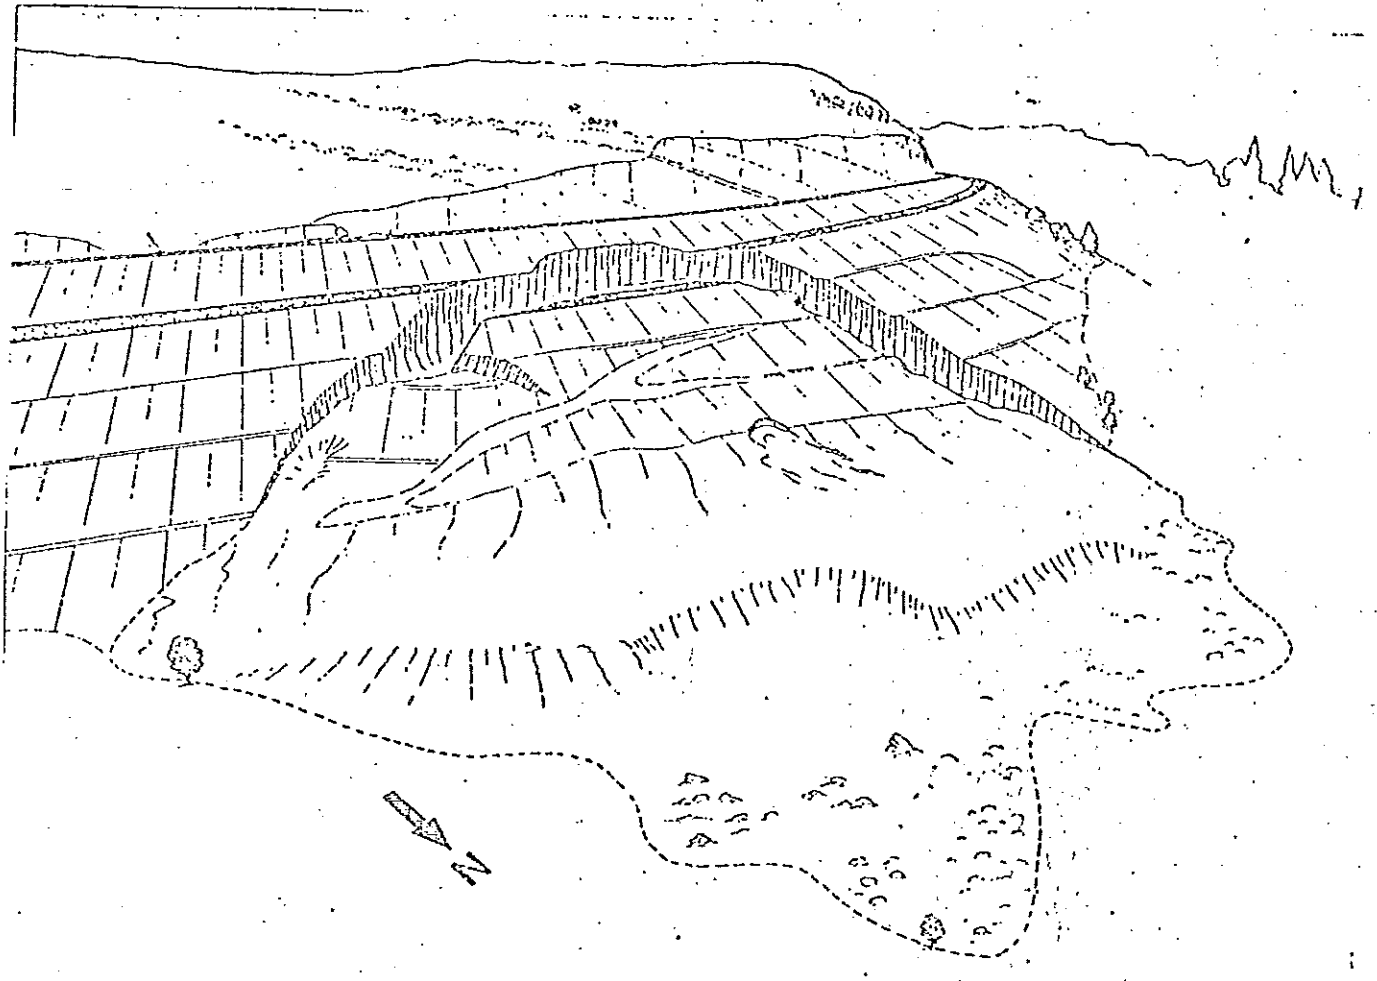
FIGURE 1. PERSPECTIVE OF SLIDE

During January 1978, after exceptional rain a section of split level dual carriageway highway on Road P39-1, near Krugersdorp, South Africa collapsed. At the failure the road was on a steep gradient as it climbs an escarpment. The road was constructed partly in cut and partly on fill, on a natural side slope of about 1 in 2. The failed section was about 80 m long and the lower carriageway dropped about 6 m. The failure zone extended about 150 m down the slope, at which point the slide debris formed a tongue approximately 200 m wide.

A view of the failure is shown in Figure 1 and a cross section through the centre of the slide is given in Figure 2.

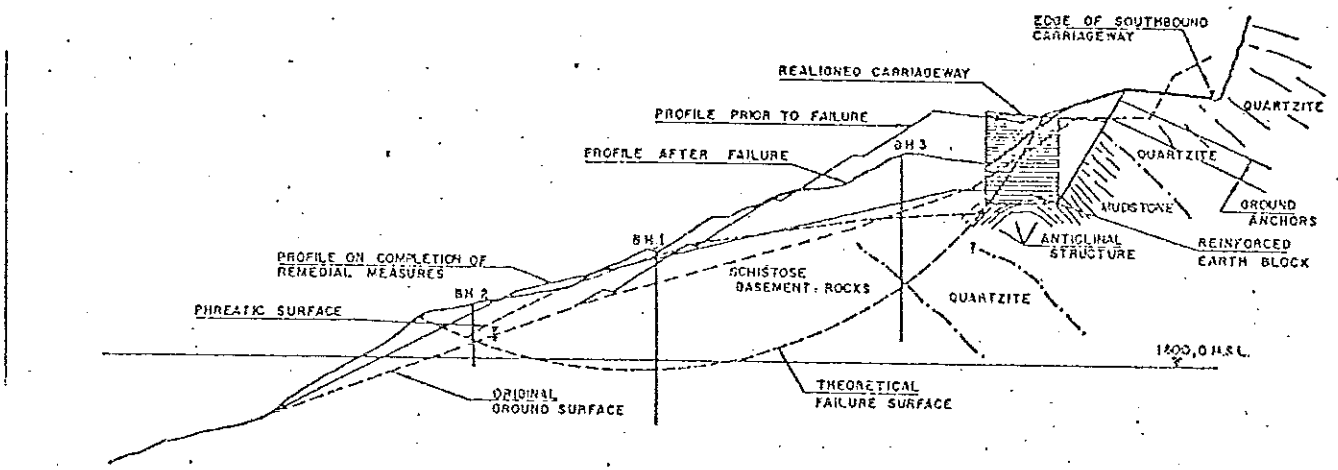
FIGURE 2. SECTION THROUGH FAILURE

The escarpment up which the road climbs consists of alternating beds of shales and quartzites of the Witwatersrand Series overlying low grade schists and phyllites of the much older Swaziland Series. In the exposed cutting the bedding planes dip at about 45° to the south west which, as shown in Figure 2, is apparently favourable for the cutting and embankment stability. Both shales and quartzites are heavily jointed with the predominant set being practically at the slope of the cutting. The underlying schists and phyllites are generally very weathered. It was expected that the dip apparent in the cutting would represent that through the failed area. However, on excavation for the reinforced earth wall, it became clear that the dip of the shale in the zone through which the failure was assumed to pass, changed radically over a width of only 10 m from about 45° south west in the exposed face to about 60° north east at the outside edge of the excavation. This is shown on Figure 2.

tale holes, tended to confirm the postulated failure arc position. This is shown on the cross section Figure 2. Since the geometry was known, the analysis became a straightforward variation of subsoil strength parameters with changes in assumed pore pressure so that $F = 1$. It was considered that measurements of actual shear strengths would be of doubtful value, since obtaining representative samples suitable for laboratory testing would be extremely difficult, particularly if the failure plane was thin.

Two reinforced earth wall solutions were examined; one on the existing road line, and the other with a realigned carriageway. The latter was estimated to cost about 75% of the former; it was the cheapest of all the solutions examined and was therefore adopted. The scheme for this is shown in Figures 2 and 3. The total estimated cost of the scheme was about \$700 000 of which about one third was for the reinforced earth structure with the remainder being for the realignment of the carriageway and the reshaping and landscaping of the slide debris. The cost of the reinforced earth including excavation, supply of all materials, erection and back-fill was about \$200/m².
