Innovative solution for a Kei Cutting problem

ABSTRACT: An innovative concept for the widening of fills over an existing sidefill has been implemented on the National Route 2 (N2) across the Great Kei River in the Eastern Cape Province of South Africa. Ten retaining walls have been constructed in which soil nails are combined with a mechanically stabilized embankment (MSE) to allow for the accommodation of traffic during construction, widening of the fills and compliance with overall stability requirements. This paper describes the reasons for the selection of this solution and the design and construction thereof. The cost and technical merits of this hybrid structure are compared to alternative solutions. The conclusion reached is that this solution economically satisfies the technical and environmental requirements and has potential to be used more extensively for widening projects in the future.

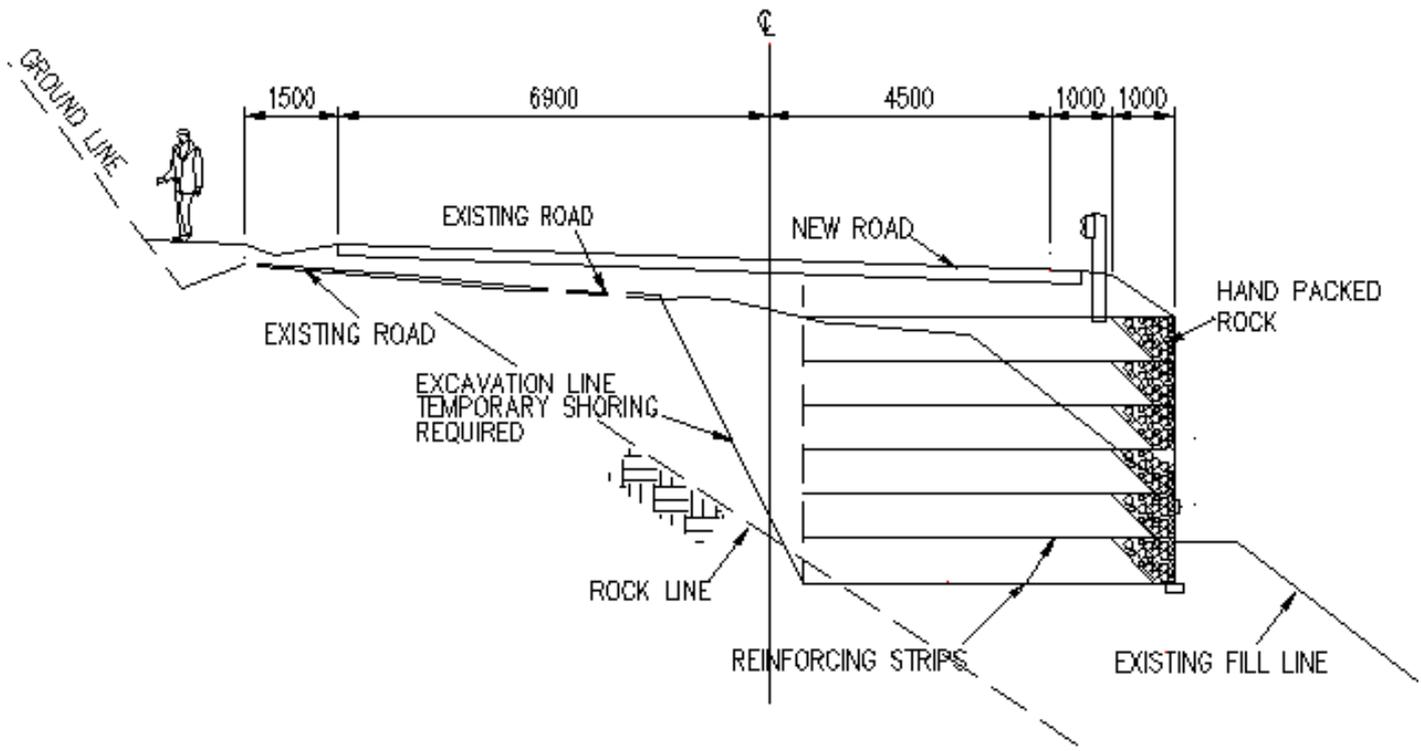
Figure 1. Typical cross section of the specified MSE solution.

Reinforced Earth's TerraTrel[®] system was specified in the tender documents. In order to enhance the overall stability of the existing fill, even when surcharged with this new MSE structure, the reinforcing strip length was extended until it nicked into the underlying rock slope as shown in Figure 1. The type of structure specified was economical and flexible enabling it to adjust to settlement of the underlying fill. In addition it would provide a pleasing natural rock appearance satisfying environmental requirements. In order to accommodate a single lane of traffic, temporary shoring of the excavation for the TerraTrel[®] mass was envisaged.

On award of the contract, it was decided that two-way traffic needed to be maintained during the construction process. The specified TerraTrel[®] structures were too wide and massive to accommodate two-way traffic as shown in Figure 1 and an alternative system for the retaining walls, which would meet all the requirements, was urgently required. This left an unenviable situation for the embankment widening designers. First of all the

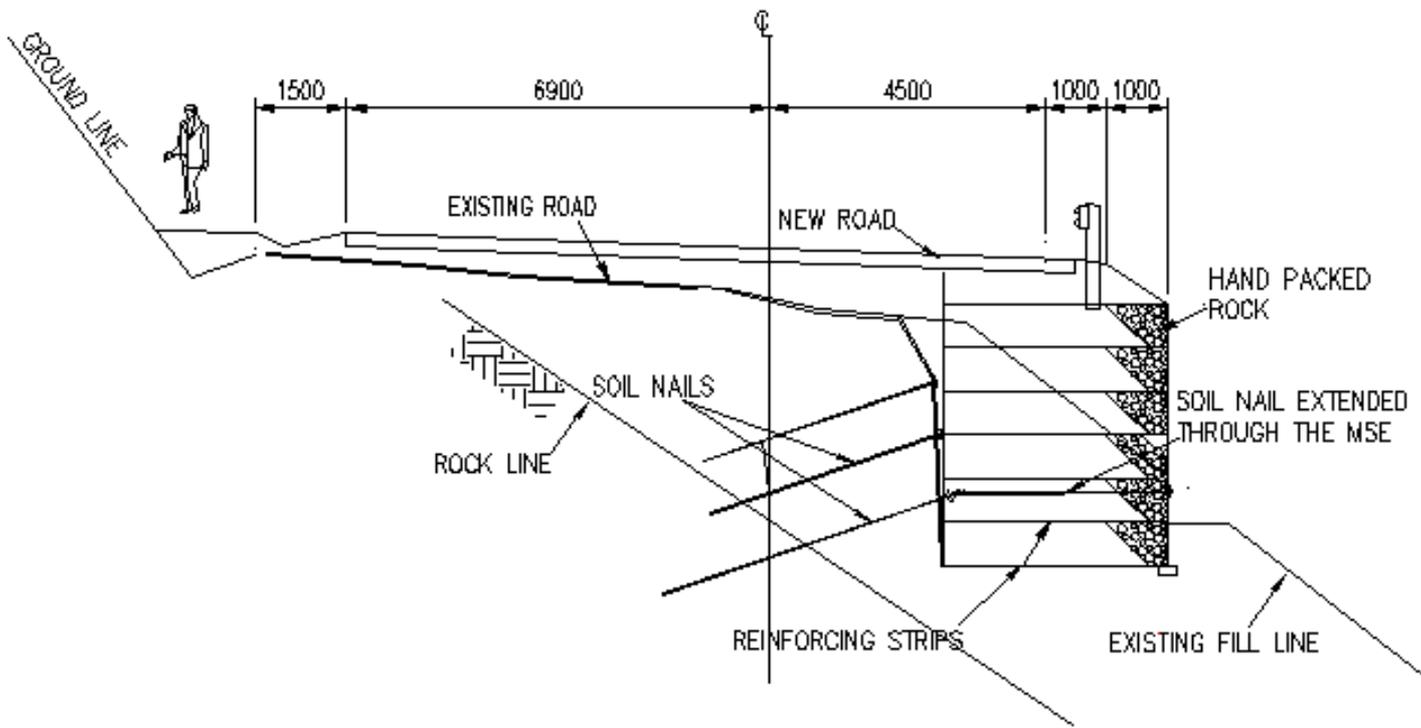
Figure 2. Typical cross section of the composite soil nail / MSE structure.

Following discussions between all parties an innovative and economical solution was proposed. This solution required a combination of a nailed system and a much narrower MSE mass. A typical cross-section of the composite soil nail and MSE structure is shown in Figure 2. This solution allows for the accommodation of two-way traffic; limits the excavation required for the MSE mass; satisfies the internal stability requirements of both the temporary nailed structure and the MSE structure, the composite nailed / MSE structure and also the overall stability requirements of the widened embankment. Finally, it provides a pleasing natural visual appearance.

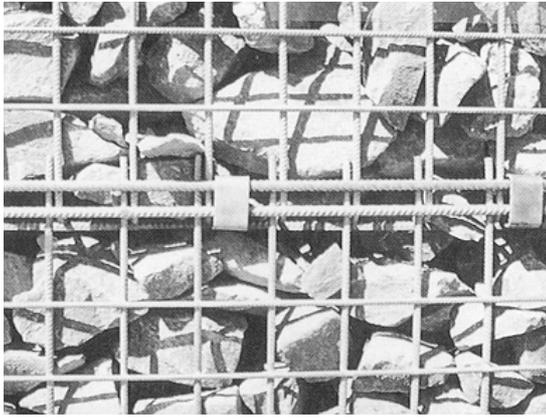
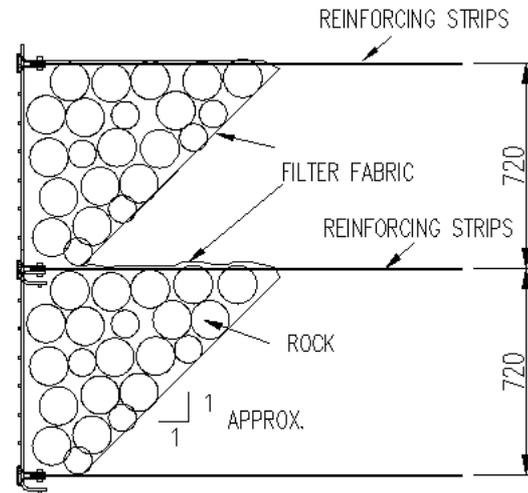
Figure 3. The TerraTrel[®] cladding.

It comprises a heavy hot dip galvanized weldmesh made up of 8 mm, 10 mm and 12 mm bars with a 100 mm by 100 mm opening. The elements are bound together by tie points, onto which the reinforcing strips are bolted. The elements are designed to concertina rather than bulge should internal settlement of the fill immediately behind the cladding occur. In order to prevent the backfill spilling through the weldmesh it is backed with a durable rock which in turn is backed with a geofabric.

An MSE structure is a composite structure comprising frictional earth, reinforcing strips and a cladding. In this project the TerraTrel[®] system comprised a backfill which was a completely, highly weathered dolerite with 100% passing a 5 mm sieve and 10% by mass passing a 20 micron sieve. For design purposes an internal angle of friction of 36° and a cohesion of zero was assumed for this material. The pH of the backfill was 6.5 and the material easily complied with electro-chemical characteristics required to ensure the design service life of 100 years. The reinforcing strips were hot dip galvanized medium tensile ribbed steel strips, with cross-section 60mm x 4 mm. The length of the strip is dependent on the height of the wall. Only 3.5 m and 4 m strip lengths were used on this project for structures up to 8 m high. The cladding is shown in Figure 3.

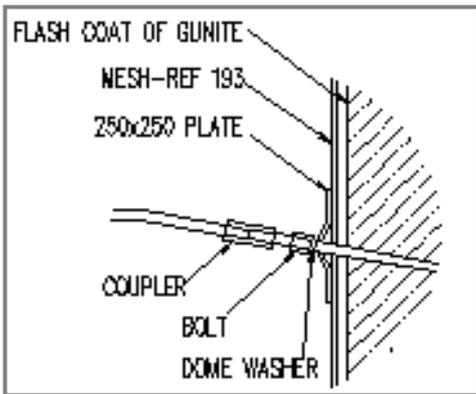
Detail 1. At the cut face.

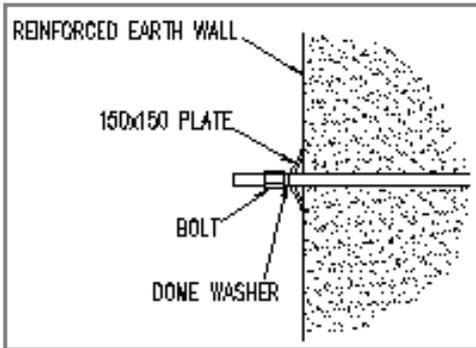
Detail 2. At the MSE cladding.

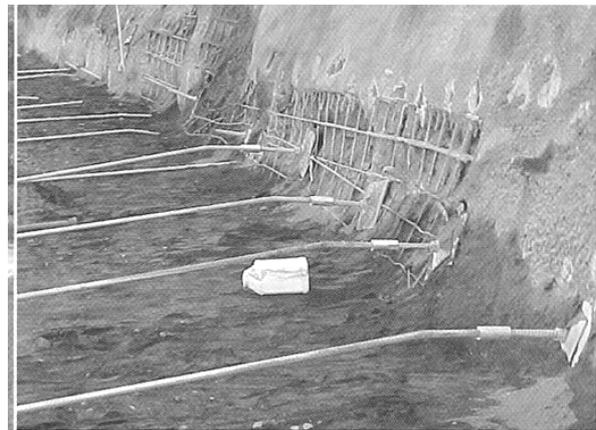
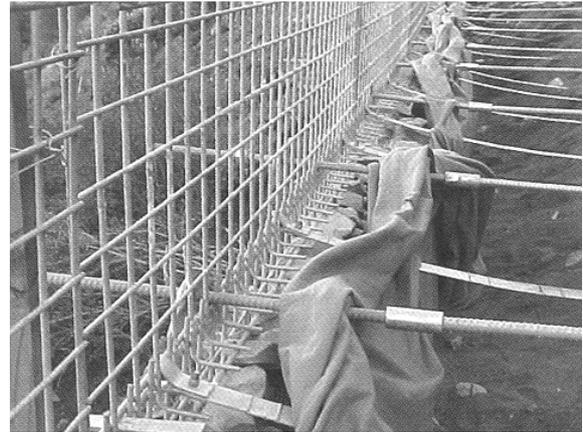
Figure 4. Detail of the nail extension.

A slip circle analysis through the nailed and MSE structures indicated that the critical slip would pass between the two structures and overall stability of the widened embankment was much the same as the original embankment. In order to enhance the overall stability of the widened embankment, it was necessary to combine the structures and this was done by extending the nails through the MSE mass. Details of this innovative nail extension solution are shown in Figure 4.

All construction takes place from behind the cladding which is a definite advantage from both construction and environmental points of view. When the level of backfill reached the first level of soil nails then the designated permanent nails were extended through the MSE mass by means of couplers, cranked nails and additional headplates, nuts and dome washers fastened outside the MSE cladding.

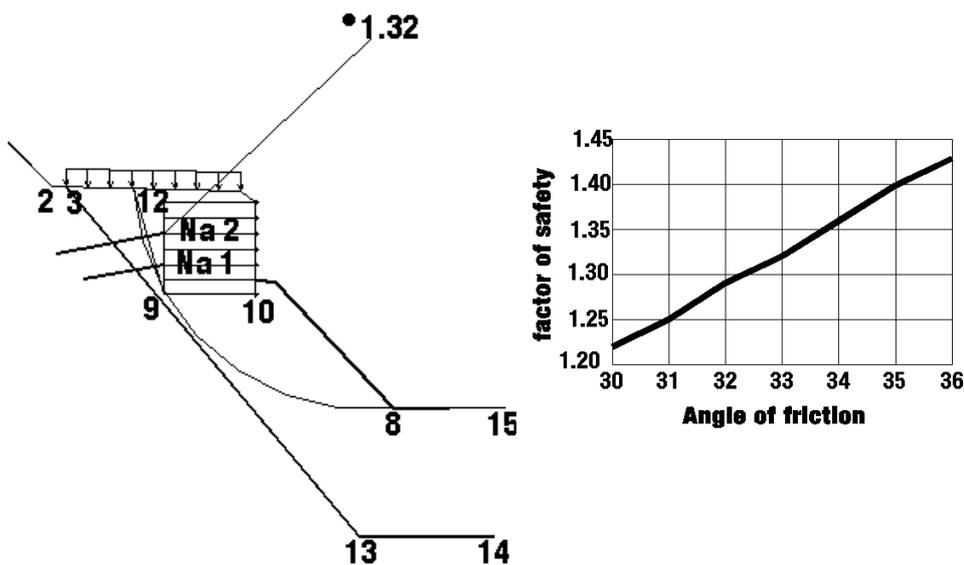
An example of the analysis of the overall stability of the road where the retaining structure is 6 panels or 4.4 m high is illustrated in Figure 5. Two layers of soil nails, spaced at 1.7m horizontal intervals, have been provided at this section. The reinforcing strips are 4.0m long, with the number of reinforcing strips per 3m width of wall varying between 3 and 5. Figure 5 gives the factors of safety for overall stability

of this typical section for values of the angle of internal friction (ϕ) ranging from 30° to 36° . The factors range from 1.22 to 1.43, indicating that it is stable. Since the original slope of the ground beneath the road was only marginally stable the adopted solution has improved the overall stability of the existing embankment in the vicinity of the retaining structures.

Figure 5. Overall stability analysis for 4.4 m high MSE structure.

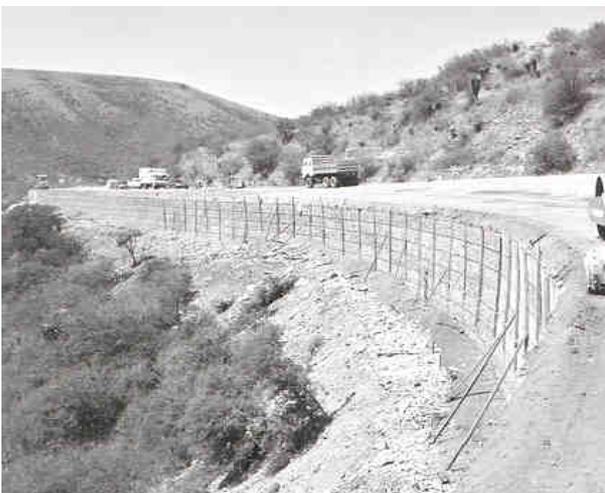
Figure 6. A view of a completed structure.

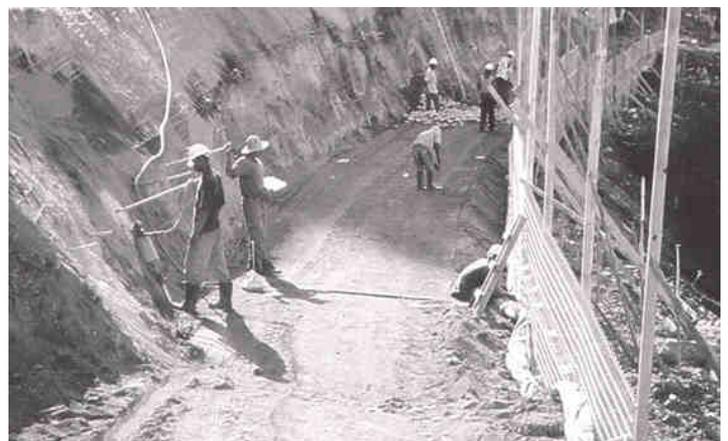
Figure 7. MSE construction and nail extension underway.
