# Backfill materials for Mechanically Stabilized Earth (MSE): African Experience

Andrew C S Smith

*Reinforced Earth (Pty) Ltd Johannesburg, South Africa*

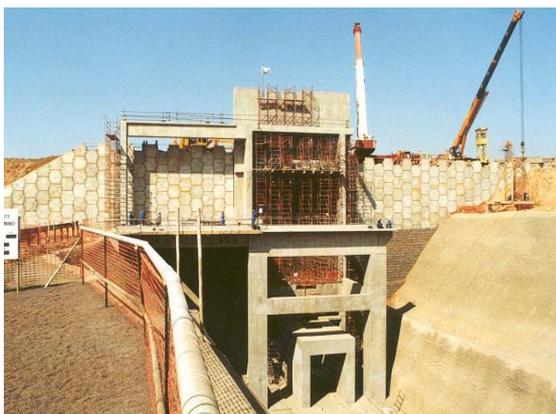
Figure 1. Cru-Klipfontein tip wall

The structure is a 30m high tip wall placed 15m below natural ground level and 15m above natural ground level. The backfill used below ground was residual felsite (very fine grained volcanic rock) with 16% less than 20 micron. The above ground backfill was hillwash with 25-30% passing the 20 micron sieve and friction angle ranging from 27.7 to 32.5 degrees. Post construction settlement of the upper part of the structure bearing on the lower structure is almost linear and is ongoing. Settlements of the order of 30 mm per year occurred between 2000 and 2006 with little sign of slowdown. These settlements have caused movement in the cladding, but do not effect the overall integrity of the structure. (See Figure 1)

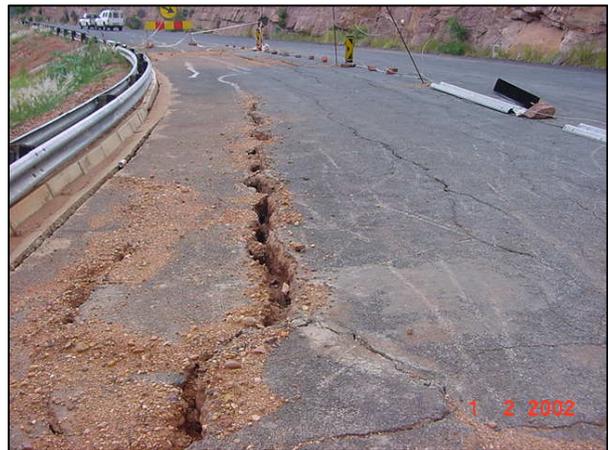
Figure 2. Kloofpass bridge approaches

The backfill properties were those of an intermediate backfill with 20-30% less than 20 microns and angle of internal friction of the order of 36 degrees for both rapid and slow saturated shear tests at 93% Mod AASHO. Construction was almost complete when a severe rainstorm struck the site and ingress of water into the MSE mass led to progressive collapse settlement,

which is defined as the additional settlement and stress changes that a soil undergoes when its moisture content increases. It is postulated that the clay bridges in the inadequately compacted backfill collapsed as they became saturated and progressive failure of the MSE ensued (Figure 2). Piles have subsequently been driven through the failed MSE embankment and support bridge decks replacing the approach embankments.

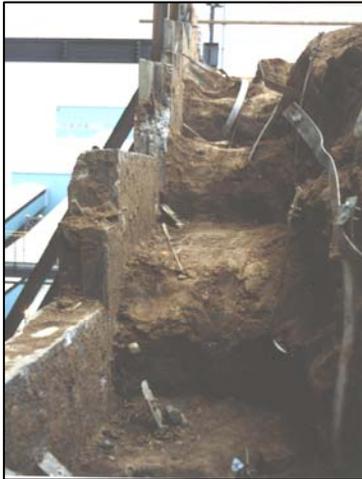
Figure 4. Grootegeluk

Aeolian soils of the interior, are sandy soils which have undergone redistribution by wind action and cover almost half of Southern Africa. Grading envelopes of these sands may be uniform except for varying amounts of clay. They could well be intermediate with clay content above 20%. When used in MSE structures care should be taken to compact the backfill adequately to prevent future collapse settlement. Figure 4 shows failure of an MSE structure in Limpopo, South Africa, due to inadequate compaction and subsequent collapse settlement.

A durable shale backfill has also been successfully used at the Grootegeluk Mine – Limpopo RSA.

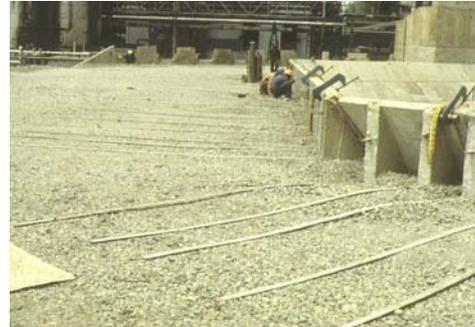
Figure 5. Vanderbijlpark

Blast furnace slag has been successfully used on 3 contracts: Faerie Glen, constructed in 1980; a structure inside the Iscor Steel Works Pretoria, constructed in 1978; a storage structure at Iscor Vanderbijlpark, constructed in 1983. The properties of the slag were consistent with pH 10.7, chloride content 35ppm and sulphate content 1680ppm. The material is an even-graded free draining gravel with 100% passing 70mm and 5% the 0.075. The electro-chemical properties fall outside the standard specifications for steel reinforcements. Sample strips were placed in the Faerie Glen backfill during construction in 1980 and extracted 14 years later in 1994. Tests showed only a small loss of zinc and no measurable loss of strength. This was also the case for test strips extracted from the Vanderbijlpark structure in 1995 after 12 years. These excellent durability results are attributed to the free draining nature of the backfill. (See Figure 5.)

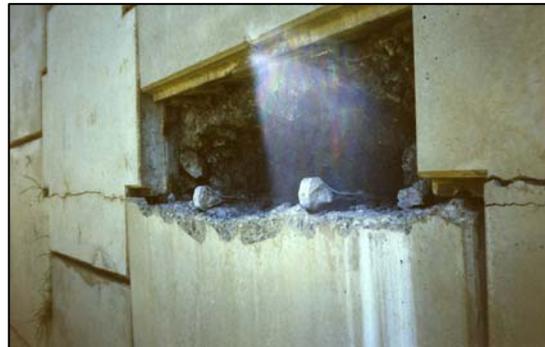
Figure 6. Dunswart

In 1998 however, RESA was alerted to cracking of the panels. Investigation determined that the problem arose because of expansion of the backfill caused by reaction of lime in the fill to ingress of water. The overall structural integrity of the structure is not affected, but the cracked panels are unsightly and ongoing repairs are necessary. The use of expansive backfill cannot be entertained in MSE structures and the material is not recommended. (See Figure 6.)

Steel slag was used for the Dunswart bridge complex constructed using galvanized steel reinforcing strips in 1987. The properties of the slag were as follows.

Mechanical: granular with 100% passing the 75 mm sieve and 2% the 0.075; grading modulus 2.71.

Electro-chemical: pH 8.2-12.4; chlorides 7-28 ppm; sulphates 432-1229 ppm; sulphides 0-1992 ppm.

Test strips were extracted in 1992 after 5 years and again in 1998 after 11 years. A sample of backfill was also removed in

1992. Durability of the strips has proved satisfactory with little loss of mass and no measurable loss of strength.

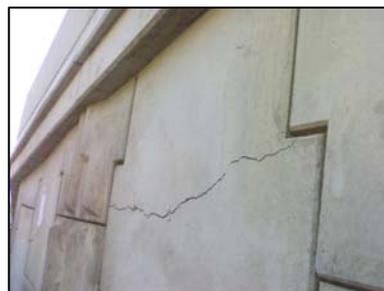
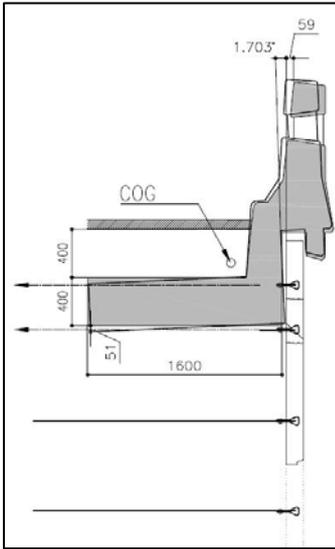
Figure 7. Western Freeway, Durban

RAP was taken as backfill on the Western Freeway Durban structure constructed during 2006. The internal angle of friction was 30° degrees. 100% passed the 20 mm sieve and zero passed the 75 micron sieve. The interlock of the binder coated aggregate fragments are subject to significant residual viscous behaviour resulting in time delayed post construction creep and consolidation of the fill. In the case of the Western Freeway this led to rotation of the crash barrier during the construction process and consequent bursting of the cladding. The settlement of the fill was monitored and once it became negligible the cracked panels were repaired and the structure was brought into service. RAP, mixed 50:50 with sandstone has been successfully used on another project. RAP should not be used on its own however and should be mixed with approved backfill for use as backfill in MSE structures. (See Figures 7 & 8)

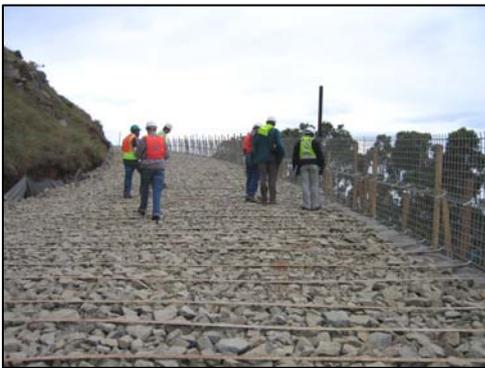
Single sized rock or stone resistant to weathering is an ideal backfill material for MSE structures. This type of material is free draining, construction can proceed in all weathers and the need for subsurface drains is eliminated. Compaction is not necessary and the material can be used to backfill areas inaccessible to compaction plant. It could also be used for backfill of structures in or under water. On the Ugie to Langeni Road (E Cape, RSA) rockfill has successfully been used with galvanized steel reinforcing strips, while 50mm stone was used with synthetic reinforcing strips.

Figure 10. Langeni –galvanized steel reinforcing strips

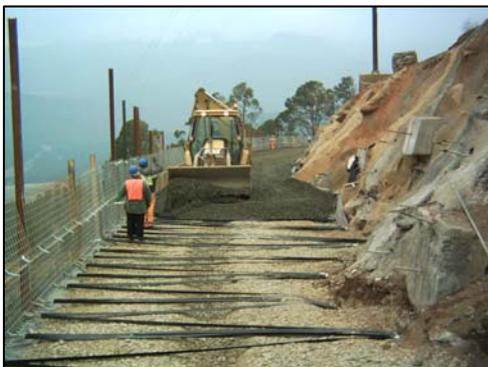
Figure 11. Langeni – synthetic reinforcing strips
