An innovative connection between a nailed slope and an MSE structure : application at Sishen mine, RSA

ABSTRACT: The expansion project at Sishen Mine Northern Cape, RSA includes the construction of a primary crushing facility. The primary crusher building is founded at a depth of 35metres below the natural ground level. MSE wing-walls are required to provide access for 400^T trucks to the tipping areas. The wing-walls are tiered and split into 14m and 21m high structures, which in effect are equivalent to higher structures because the dry density of the hematite backfill is 33kN/m³. Insufficient space was available for placing the reinforcing strips on one of the lower walls viz. Wall B. Additional excavation to accommodate the strips was not feasible and a solution was required to connect the narrow MSE structure to the existing cut slope. This has been undertaken by the installation of nails into the cut slope; attaching a high friction strip to the nail heads and then lapping shortened reinforcing strips attached to the cladding with the friction strip. The frictional interaction between the MSE reinforcing strips and the extended nails ensures the internal stability of the MSE

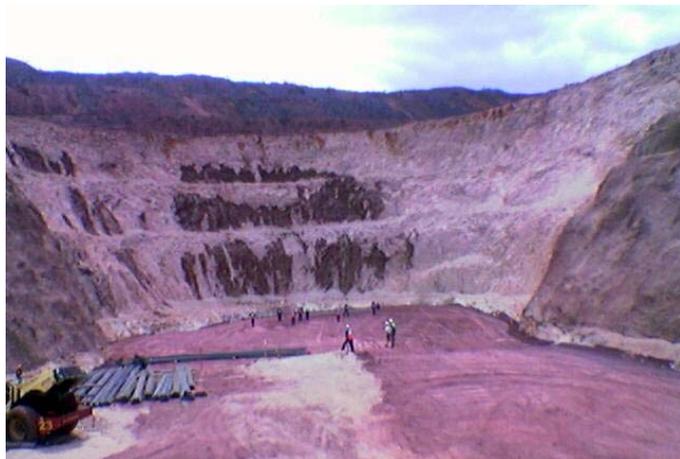
Figure 1. Excavation completed

The new primary crusher is situated at the edge of the existing pit and in an area where the existing pit had been backfilled. Excavation through the natural inside edge of the pit as well as the backfilled material was undertaken in order to found the structure at the minus 35m level. Figure 1.

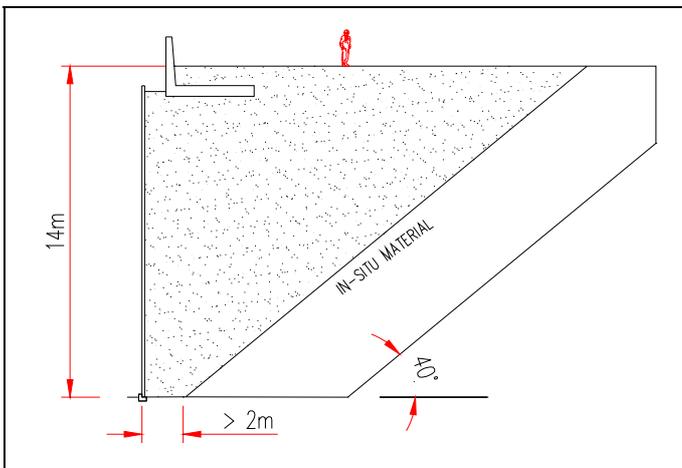
Figure 2. Wall B – Typical cross section

The existing slope was, in one location, as close as 2 meters from the projected position of the wall facing, with an inclination of about 40° about the horizontal. Further excavation of this excavated slope was avoided on account of overall stability concerns. The position of Wall B was relocated several metres nearer the excavation line and it became necessary to find a cost effective solution for a 14 m high vertical structure, with an available space at the bottom of about 2 m, i.e. 15% of the height (Figure 2). The standard practice for MSE retaining walls lies generally between 60% and 70%, with a minimum set in the major design codes to 40% at the base. The recent Shored Mechanically Stabilized Earth (SMSE) Wall Systems Design Guidelines, edited in February 2006 by the US Central Federal Lands Highway Division, states that the width at the base should be at least 0.3H and concentrates on vertical and near-vertical backslopes.

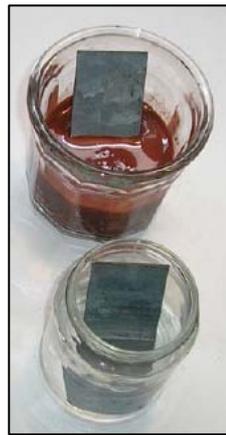
A test was done to compare the corrosion behaviour of a galvanised steel sample placed into saturated hematite, with a similar sample placed in tap water. The rates measured showed similar behaviour. The resistivity of the hematite ore saturated with de-mineralised water at 20°C is $11,600 \Omega\cdot\text{cm}$, and the pH level is slightly alkaline at 8.3. About 1% of fine elements is enough to give to the water a strong red colour, similar to blood, which gives its name (in Greek) to the ore.

Figure 3. Comparative corrosion testing between saturated hematite and de-mineralised water

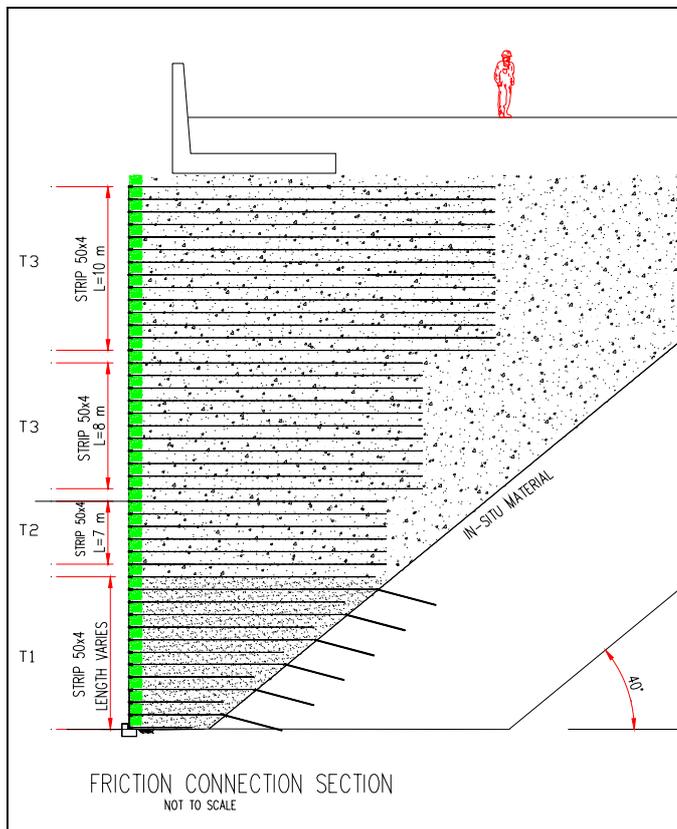
Figure 4. Sishen cross section

A similar layout was proposed for the Sishen structure. Instead of trying to make a positive connection between soil nails and the new facing, leading to issues described above, it was decided to make use of the friction connection between reinforcing strips extending from the facing and specially designed highly frictional ladder reinforcements connected to the nails. The elements were designed so that an overlap of 2 metres would be enough to ensure stability. A patent on this concept was filed in January 2006 by Terre Armée Internationale.

The cross section is basically divided into two sections. The lower section on the RHS of the crusher building was too narrow for standard MSE technology, so the friction connection was used to link the reinforced soil mass to the slope. The upper section was constructed using standard MSE technology.

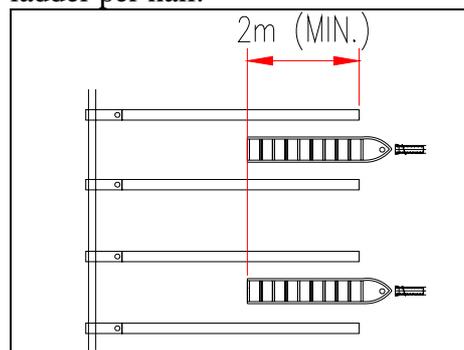
Since the nails are independent of the reinforcing strips the positioning of the nails in the excavated slope does not have to comply with the position of the reinforcing strips. The nails were approximately twice as strong as the reinforcing strips and consequently their density was approximately half that of the strips. A friction strip was required to bond two reinforcing strips to one nail and led to a specific design of the friction ladder. Depending on the level, one or two such ladders were connected to one nail head. Figure 6 shows a typical top view with one ladder per nail.

Figure 6. Typical top view of a layer comprising steel strips connected to the facing and ladders connected to the nail heads

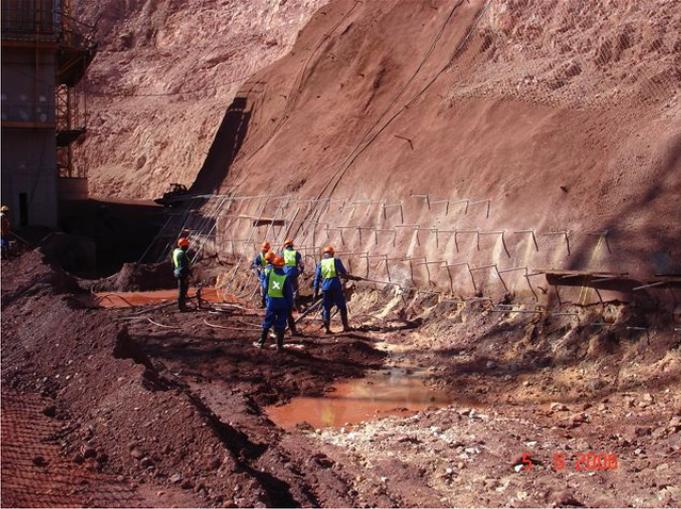
Figure 7. Nail installation

The schedule for construction of wall B was tight. Firstly, all the nails were installed in early June 2006 (Figure 7), followed by the construction. Free draining crushed stone backfill was specified for the 2m wide zone extending from the excavated face. This material facilitated compaction of the backfill around the protruding nail heads.

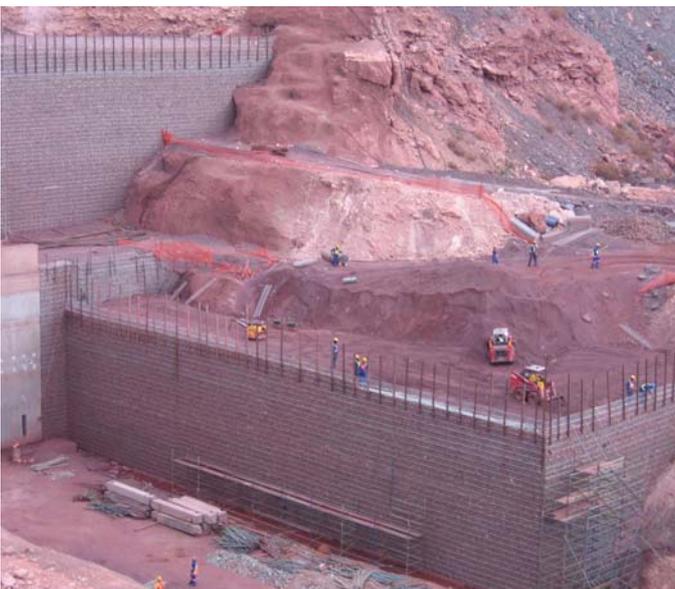
In places, the spacing between cladding and cut slope was less than 2m. To ensure sufficient strength at these locations, concrete was used instead of backfill. A mass concrete foundation was constructed below the entire length of the nailed section of Wall B to ensure adequate bearing capacity of the foundation. After one or two lifts, when the spacing reached 2m, the hematite backfill was used. In early August 2006 construction of wall B reached the stage shown in the photograph (Figure 7).

Figure 7. Wall B close to completion

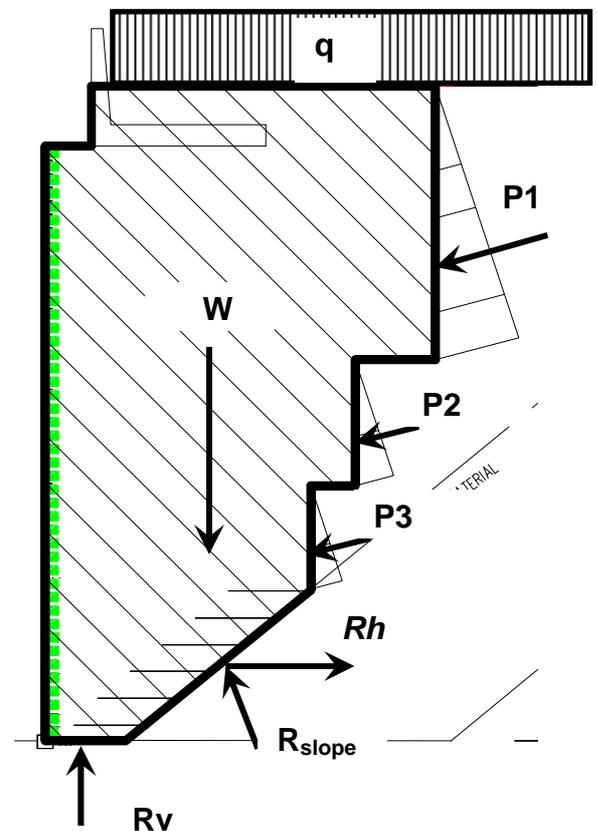
Figure 8. Block horizontal stability

A conservative analysis of the horizontal stability was undertaken, considering that the foundation soil did not offer any sliding resistance. Consequently all the horizontal force due to the earth pressure in the upper section and to the sliding on the slope in the lower section was distributed among the soil nails and ladders. The total resisting force R_h is determined so that the horizontal stability is ensured (Figure 8).

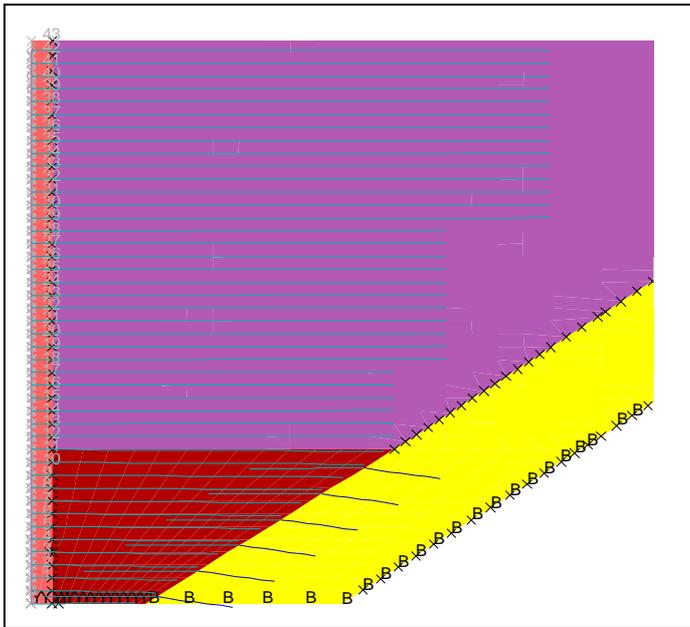
Fig. 10: Flac model

This was done with the help of the geotechnical finite difference program, Flac 5.0, which incorporates a specific structural element to model discrete reinforcements as steel strips or ladders. The modeling was made with the “large displacements” option which allows better simulation of arching and membrane effects (so-called second order effects). Figure 10 shows the overall model.

This modeling confirmed that overall stability is ensured, but the upper two of the six layers of ladders connected to nail heads are more stressed than the four lower ones, which required an increase in the density of ladders for these two layers. This is due to the fact that the existing slope is stiff, and settlement of the reinforced fill during construction, tends to overstress the upper connector levels. One could comment that once again the classical slope analysis programs do not allow us to represent any type of overstressing due to deformation or differential settlement. Figure 11 shows the estimated relative tensile forces in the reinforcements of the lower section. The higher tensile force in the lower ladder

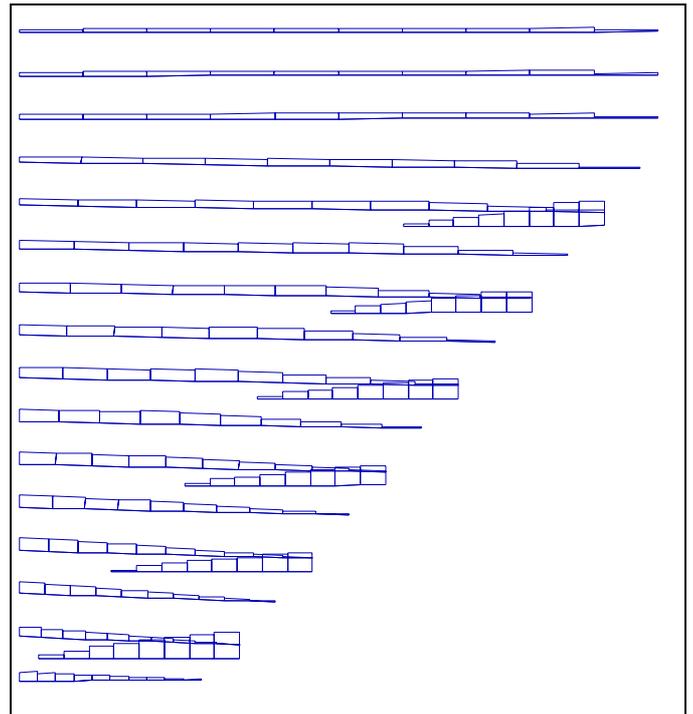
is artificial due to the assumption of zero friction capacity at the bottom of the fill.

Figure 11. Relative tensile forces in the reinforcements of the lower section

The connection between the nail and friction ladder is by means of an eye bolt and a shackle. A Wheatstone strain-gauge bridge was used to instrument six shackles. These were calibrated at the University of Pretoria and installed in pairs at three levels viz. 0.32m, 1.28m and 2.20m above the foundation. The lowermost and middle sets showed almost zero tensile stress. One of the top shackles showed a tensile load of 85.8kN while the other top shackle did not respond, probably due to failure of the electronics in a harsh environment. These results agree with the numerical analysis and confirm that the upper ladders are more stressed than the lower ones.
